Manhole Inspection Summary

Manhole # S47MM_018MH

Insp Date: **5/7/08 11:28 AM**

Location Address: **Patterson Park Ave**

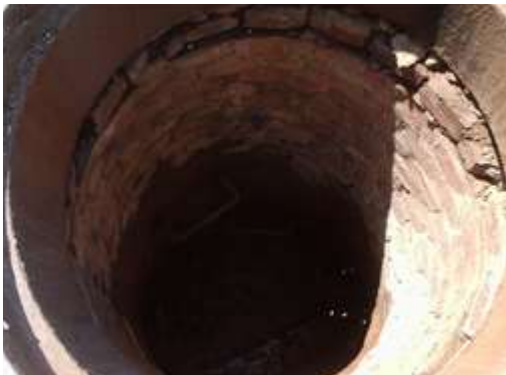
Defect 2

Infiltration

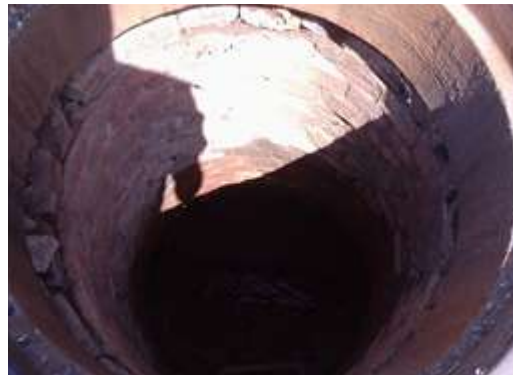
Defect 1

Deterioration

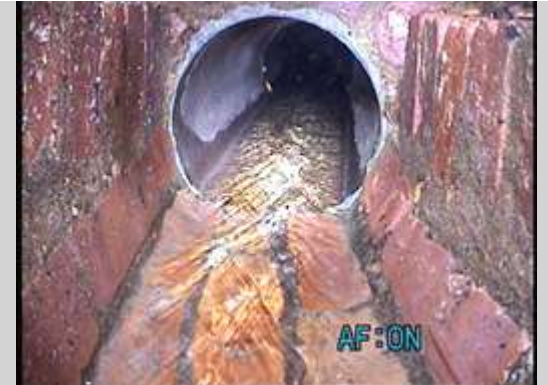
12 O'Clock Outflow

8 in. Circular Gravity Sewer
Pipe Out @ 12 O'Clock

Pipe Height: **8.4** (in.) Rod and Bar (Angled)
Pipe Material: **Clay** ☐ Pipe Lined
Invert Depth: **9.05** (ft.) Flow Characteristics: **Fast**
Deposits: ☒ None ☐ Mud ☐ Sludge ☐ Debris ☐ Grease
Silt Depth: (in.) Deposits Extent:
Infiltration: **None** Pipe Seal Cond: **Sound**

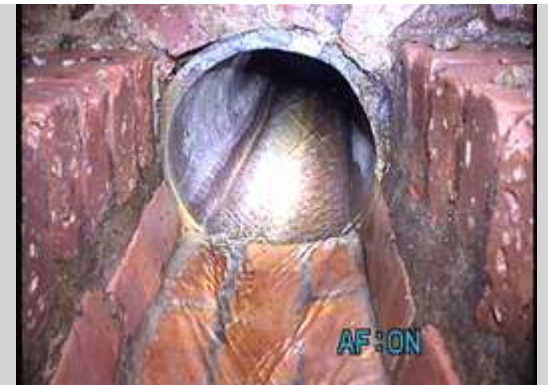
6 O'Clock Inflow

8 in. Circular Gravity Sewer
Pipe In @ 6 O'Clock

Pipe Height: **8.4** (in.) Rod and Bar (Angled)
Pipe Material: **Clay** ☐ Pipe Lined
Invert Depth: **8.90** (ft.) Flow Characteristics: **Fast**
Deposits: ☒ None ☐ Mud ☐ Sludge ☐ Debris ☐ Grease
Silt Depth: (in.) Deposits Extent:
Infiltration: **None** Pipe Seal Cond: **Sound**
